Field Testing of New Novel Technique for Controlling Crevice Corrosion on Rocker Assemblies

WAYNE SOUCIE and NANCY HEIMANN, Elisha Technologies Co. LLC, Moberly, Missouri

IBC-04-13

ABSTRACT: Deterioration of bridge expansion rocker assemblies has been an on going problem for bridge maintenance management. Typical coating systems cannot sustain the high compressive loads and movement of assembly. This paper reviews design, installation and five year performance of a new environmentally benign gel protection system to provide long-life corrosion protection.

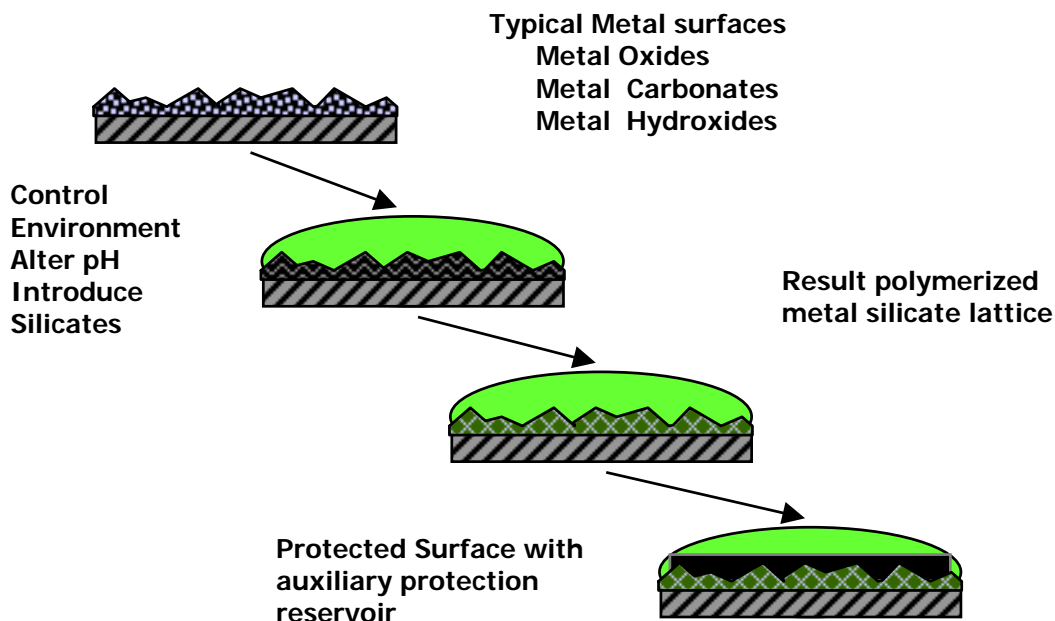
Figure 1 - Surface Mineralization Reaction Mechanism

Much of the success of the SM surface chemistry can be attributed to the reaction mechanism (Figure 1).

This mineral reaction mimics chemistries found in nature and is tailored to metal finishes. The process creates a tightly adhering interface between the metal and silicate by binding the silicate components with the metal ions from the substrate surface. This method offers many advantages including a simple application and two forms of surface protection, adding a physical barrier and alloying with the metal substrate to make it less galvanic, thus more resistant to corrosion.

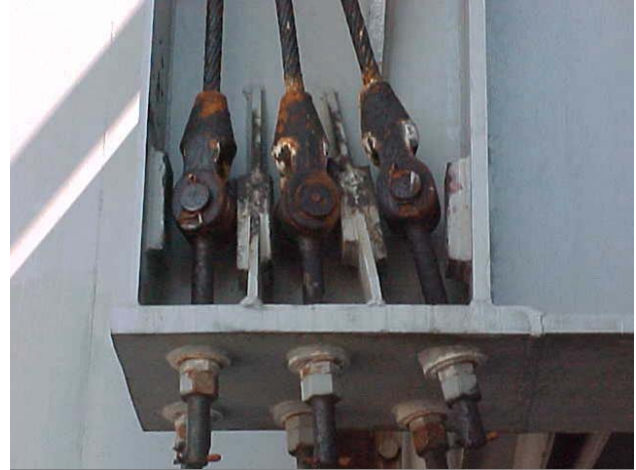
Figure 2 – Typical Corrosion on US Navy Deck Edge Elevator Cables

Adaptations of surface Mineralization technology have also been incorporated in to wire rope corrosion remediation. This particular system has been installed on approximately 40% of NS Navy aircraft carrier deck edge elevators (Figure 2 & 3).

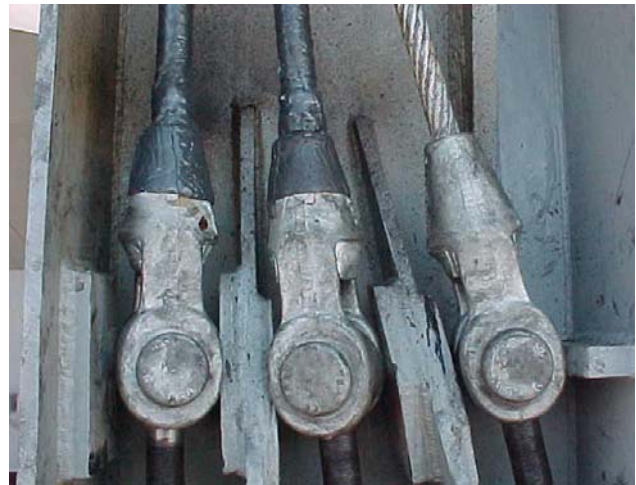
Figure 3 - US Navy Deck Edge Elevator Corrosion Remediation

Based upon the corrosive conditions, an alternative approach was developed to improve corrosion protection of the devices. The design path was "design by similarity" to the deck edge elevator wire rope application that has been successfully employed by the US Navy (Figure 3). The deck edge kit has been installed in 40% of the applicable vessels in the US Navy. Many of the same design factors come to play in this application as with the deck edge elevator application. As with the deck edge elevator application, washout is a significant concern. Therefore, a splashguard was incorporated with gel application in order to provide mechanical and corrosion protective materials. In March of 2004 evaluation of the functionality of an Elisha repair kit was initiated.

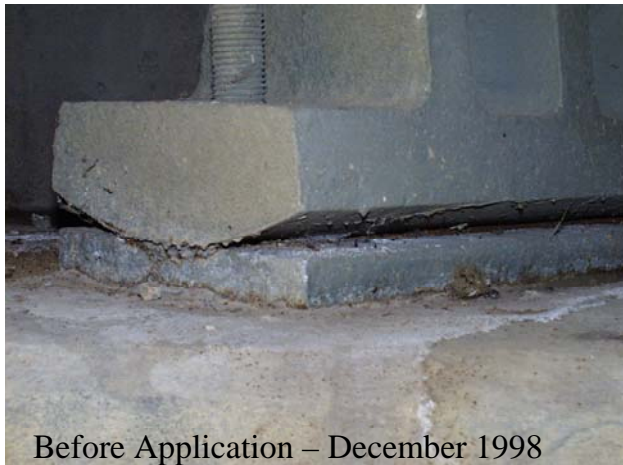
Figure 4 – Rocker Assembly Before Application - December 1998

TEST LOCATION - A highway overpass bridge on the south bound lanes of US highway 63 approximately 5 miles south of Moberly Missouri was selected as the evaluation site. This particular bridge is supported by conventional expansion rocker assemblies. The rocker assemblies located at the bridge abutments at each end of the span were chosen for ease of access and the demonstrated high corrosion exposure caused by the collection of deicing salts through the expansion gap between the bridge deck and the abutments.

The rocker assemblies were inspected periodically to collect data with regard to the progression of corrosion on the standard rocker assemblies and the units that were protected using E-2400 gel. Photographs of the progression of corrosion are shown in Figures 4 – 8.

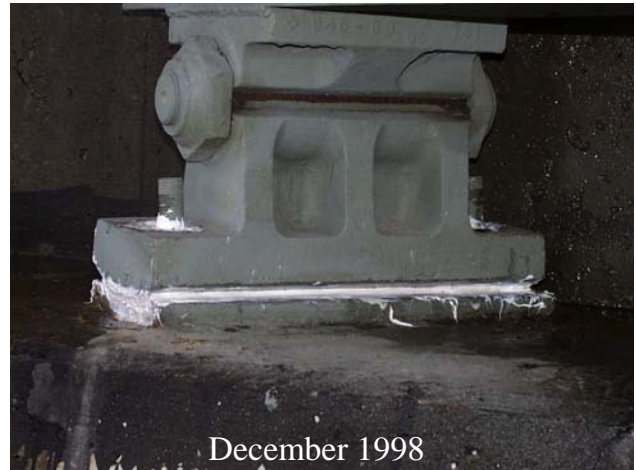
Figure 5 – Rocker Assembly After Gel Application - December 1998

APPLICATION - On December 29, 1998, alternating rocker assemblies were cleaned to remove debris and Elisha E-2400 gel was applied on the bearing plate and the rocker contact surface. In addition the locator bolts holes were filled with E-2400 to minimize the potential for water infiltration via this pathway. On one rocker assembly the exposed area of the wrist pin joint was also coated with E-2400 to determine the effect this product on inhibiting corrosion in this area.

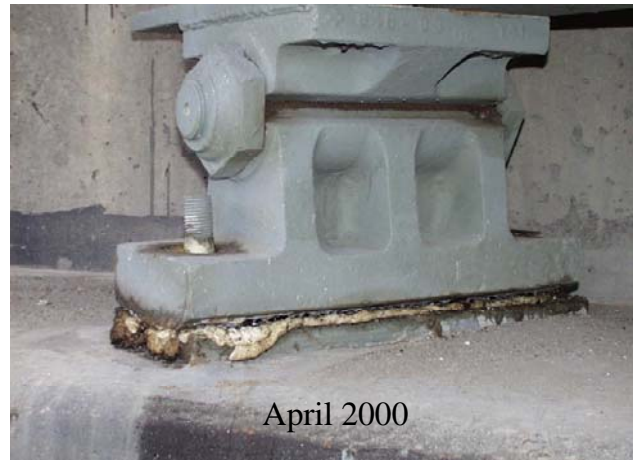
Figure 6 – Rocker Assembly Inspection – April 2000

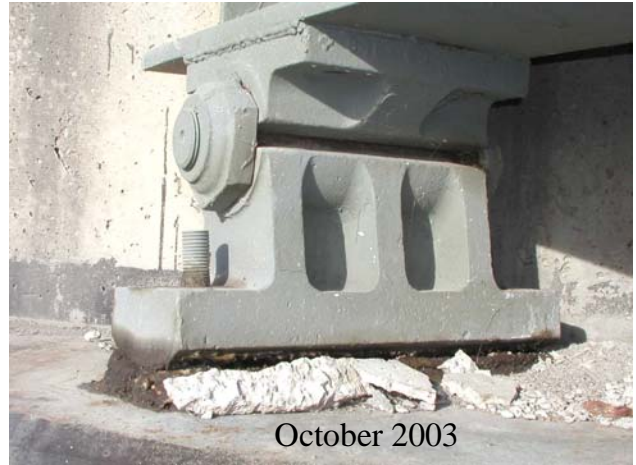
Figure 7 – Rocker Assembly Inspection – October 2003

SUMMARY RESULTS/ OBSERVATIONS - After five years exposure, the rockers not protected by the E-2400 gel continued to exhibit corrosion activity. The assemblies protected by the gel have not exhibited recurrence of corrosion in the areas where the gel was applied. The gel appears to resist washout and displacement by movement as evidenced by minimal displacement of material from the original installation. Some leaching of protective material is occurring, as evidenced by progression of oil to a distance of 0.75" from the mass of the product. The gel material remains tacky and compliant on the surfaces of the rocker. By remaining pliable, the gel is able to maintain contact with the surfaces to be protected. Dust dirt and debris have collected along the edges of the application but this collection has not impaired the functionality of the gel as a corrosion inhibitor. E-2400 is recommended for incorporation into bridge design, construction, and maintenance engineering specifications.

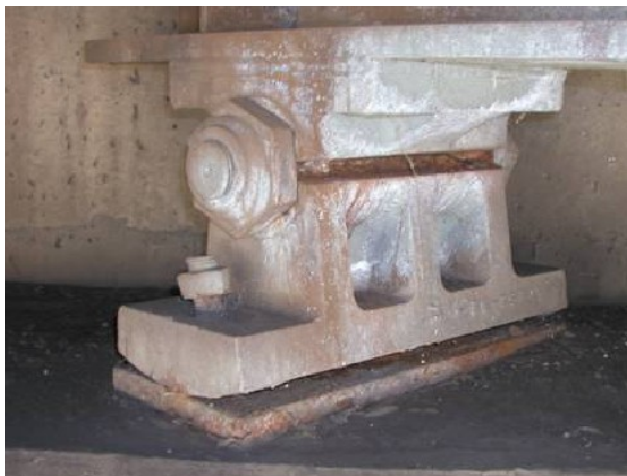
Figure 8 – Uncoated Rocker Assembly Inspection – October 2003

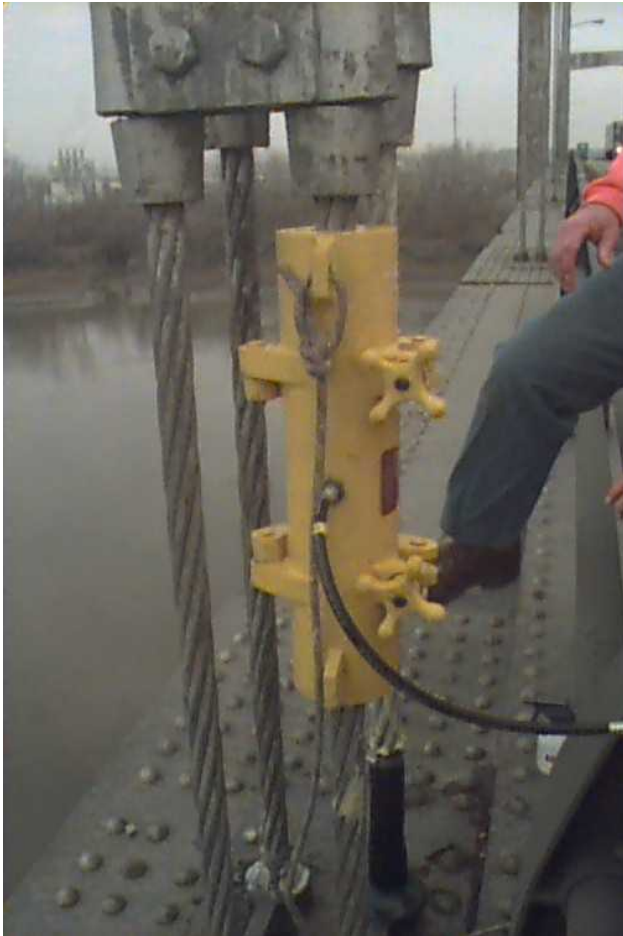
**Figure 9 – Bridge Stay
Pressure Lubrication – March 2004**

APPLICATION - Stay connecting points were cleaned with wire brush to remove debris. Elisha E-1270 wire rope lubricant was injected into the wire rope stay with a pressure injector for a distance of approximately four feet above the traffic deck (Figure 9). Stretch film was spiral wrapped around the application. A two-step mechanical protective sleeve of DPS 601 mastic material was applied. The base was covered with two pieces of mastic material extending approximately two inches up the wire rope. A large piece was cigarette wrapped around the bottom 12" of the application with a one-inch overlap. A stainless steel band clamp was used at the top of the application to compression the top entry (Figure 10).

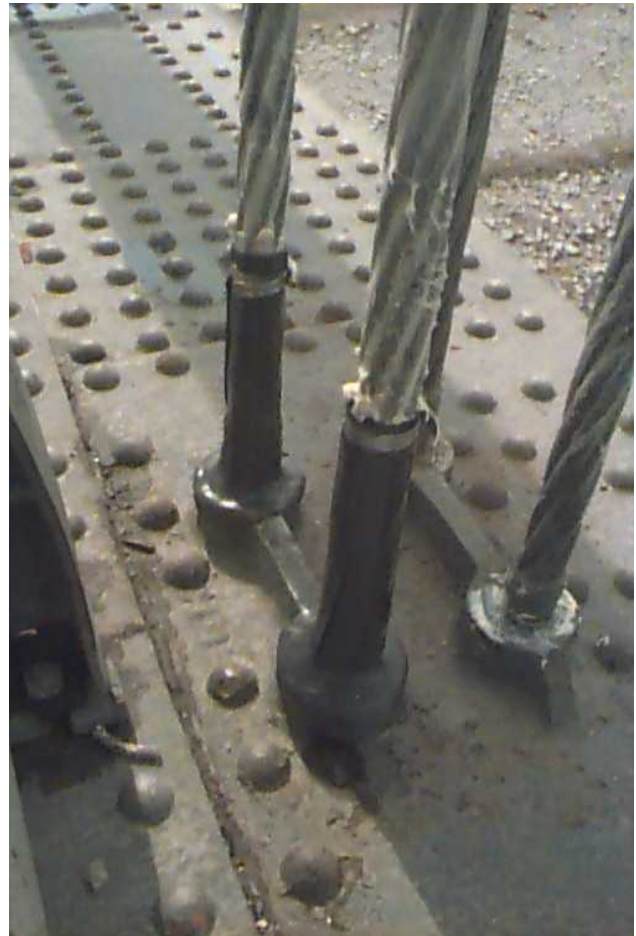
**Figure 10 – Bridge Stay
Finished Application – March 2004**
