Two Year Saltwater Immersion Simulation Testing

To prove the effectiveness of the RG (reactive gel) family of products, we tested it in a 5% salt solution. To make the test more severe, we introduced oxygen to the water through aeration tubes. Also we used the most porous type of insulation, which is fiberglass.

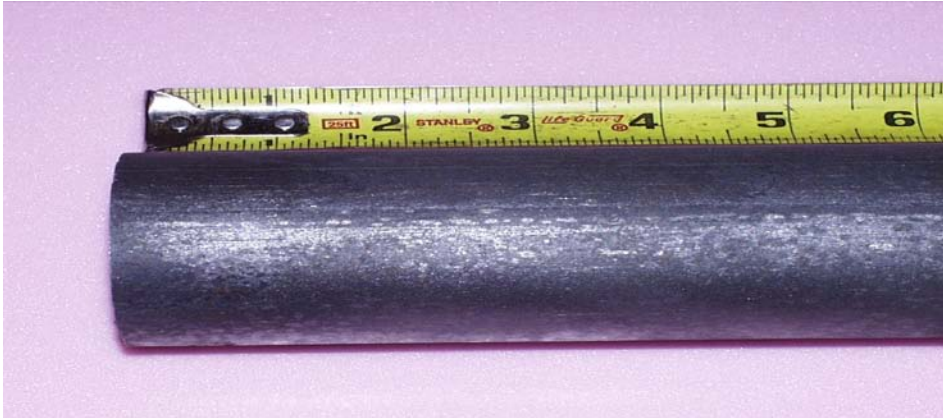
Both bead blasted pipe and mill scale as received were used in the test. A closeup of bead blasted pipe is above.

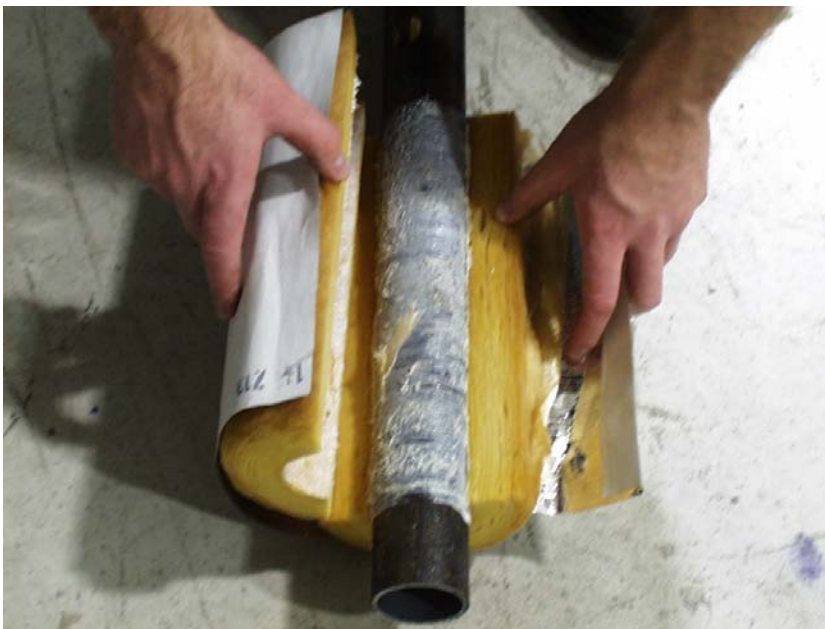
The RG reactive gel was spread over the pipe and the fiberglass insulation placed over the bottom portion. The untreated portion acted as a control.

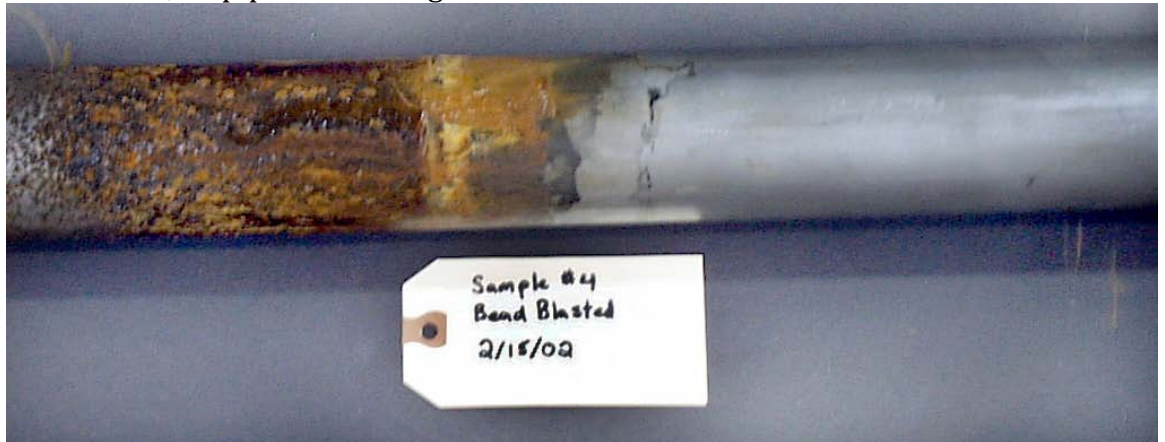
At 31 Days

At 31 days, a pipe was removed and cleaned. A difference in corrosion is already apparent. Note the transition area above the tag; at this area the insulation cover slipped down a couple of inches during the test. When this was discovered, all pipes remaining in the saltwater bath had the insulation secured and

the test proceeded.

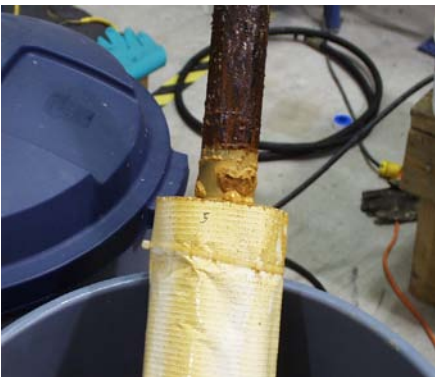
At 81 Days

At 81 days, this sample was removed. This pipe was one of those with mill scale as received. It had no corrosion on the treated area.

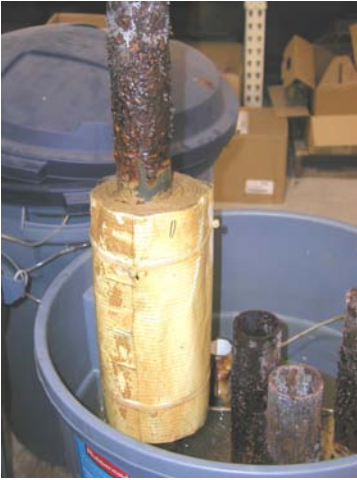
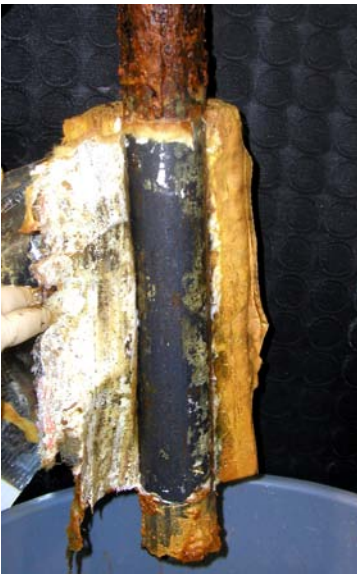
At 365 Days

At 365 days, this sample was removed. Inspection showed no corrosion on the treated area.

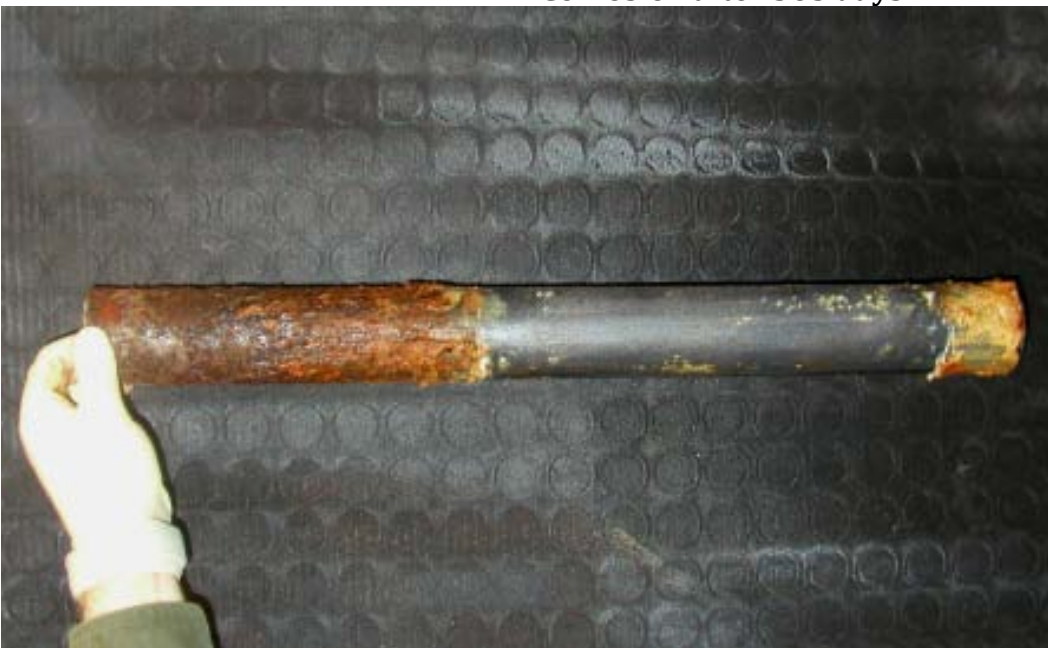
Corrosion after 365 days

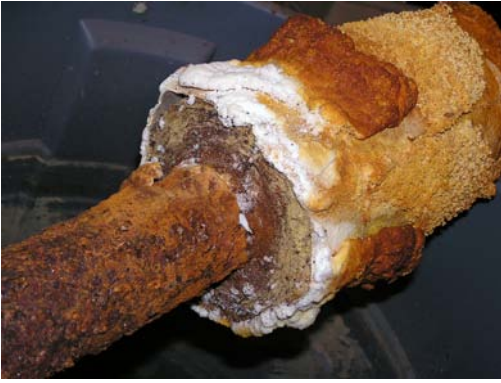
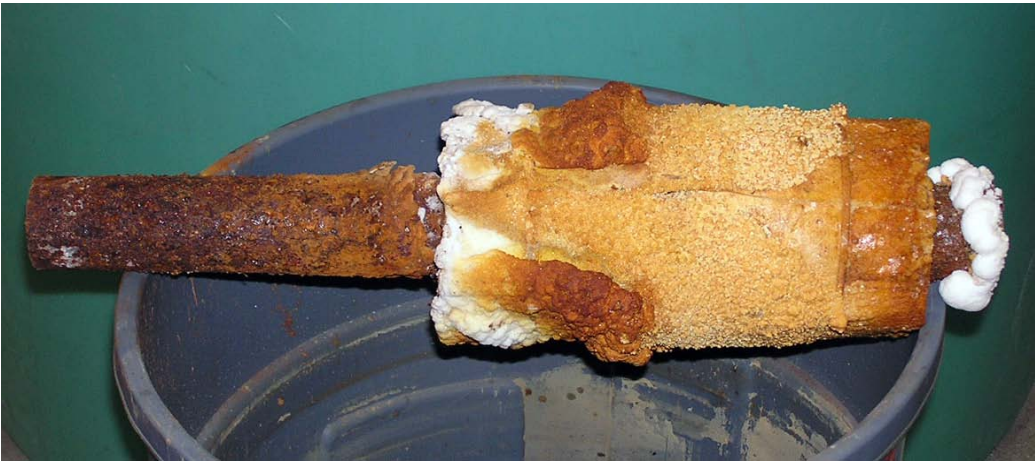
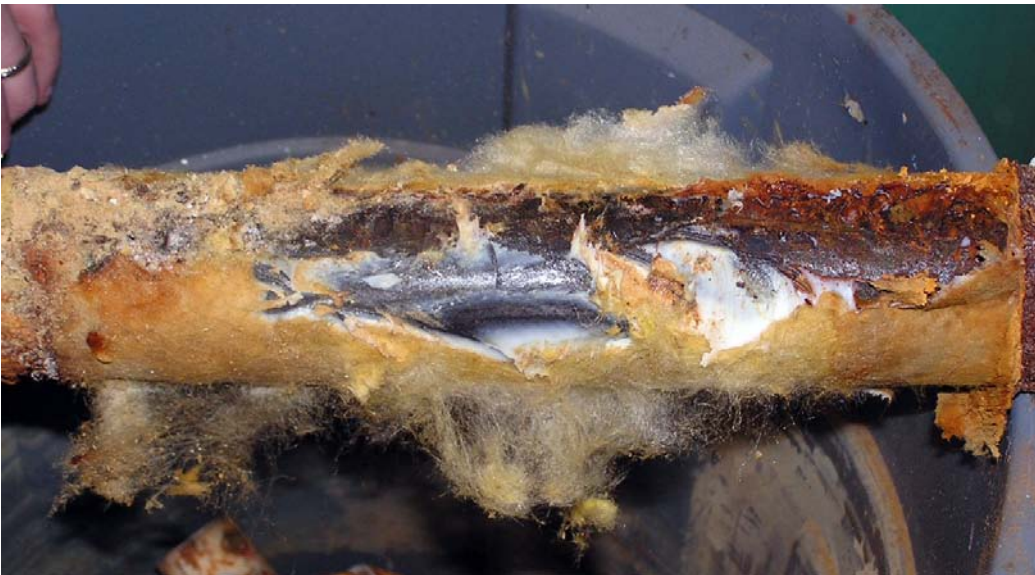
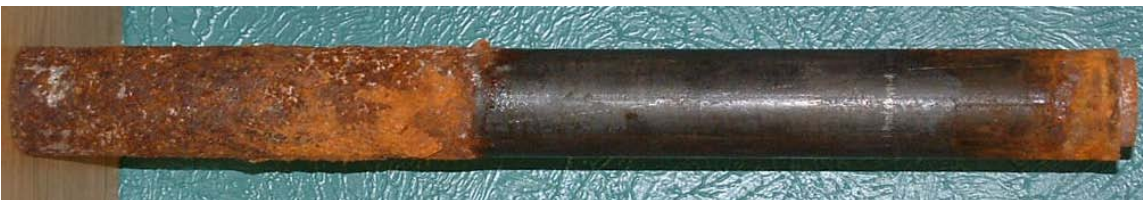
At Two Years

After two years, the insulation had begun to rot, but there was almost no corrosion on the treated area under the insulation.
