InterCorr®
International, Inc.
Services, Systems, & Software

Test Report: L983562KT

TEST REPORT - CUI SSC TESTS AISI 304 STAINLESS STEEL

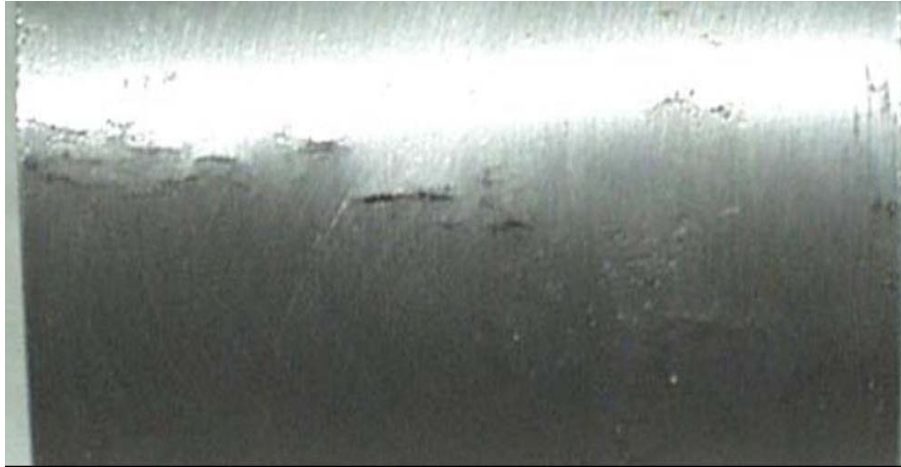
UNCOATED SPECIMEN #6190-1

Figure 1 - Untreated U-bend specimens following CUI exposure.
Note branched SCC originating from localized corrosion sites.

Both untreated U-bend specimens showed evidence of SCC originating from regions of localized corrosion on the tension surface. The cracks are shown in Figure 1 which indicate the branched nature of the cracking. By comparison, as indicated in Figure 2, neither of the two U-bend specimens treated with **RG-2400®** showed any evidence of localized corrosion or SCC.

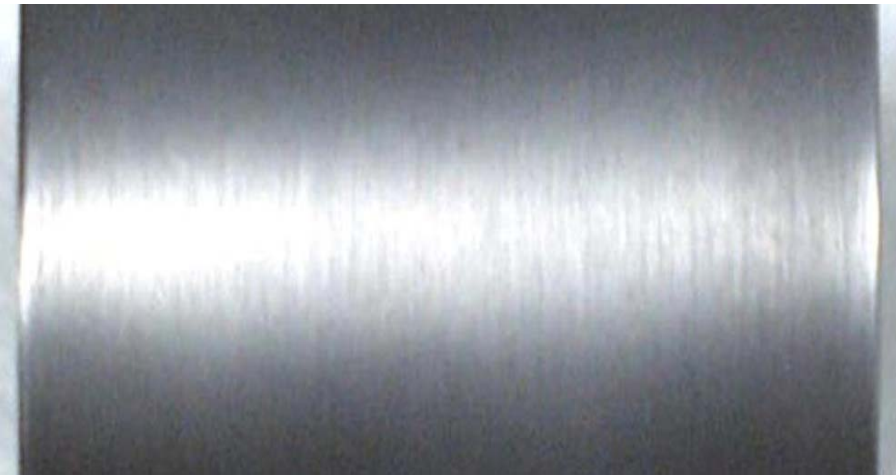
COATED SPECIMEN #6190-3

Figure 2 - RG-2400® treated U-bend specimens
following CUI exposure. No SCC observed
